## VEHICLE INSPECTION REPORT

**SJ16NXB**

### Mercedes-Benz Antos 1827

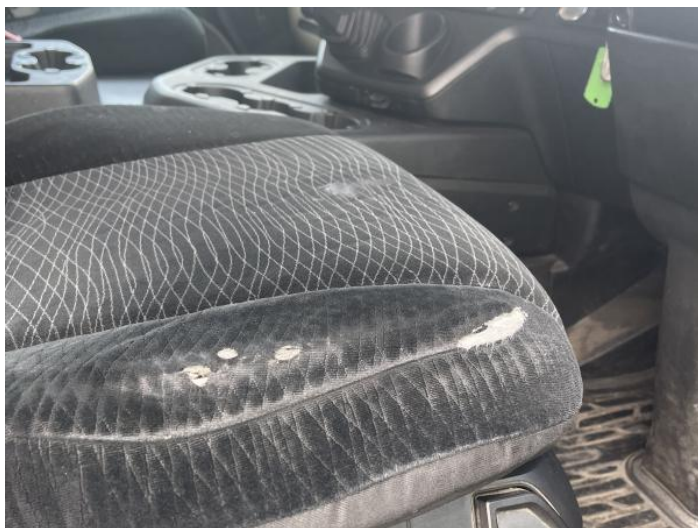
1: Seat Base Cover osf  
Torn  
Over 3mm

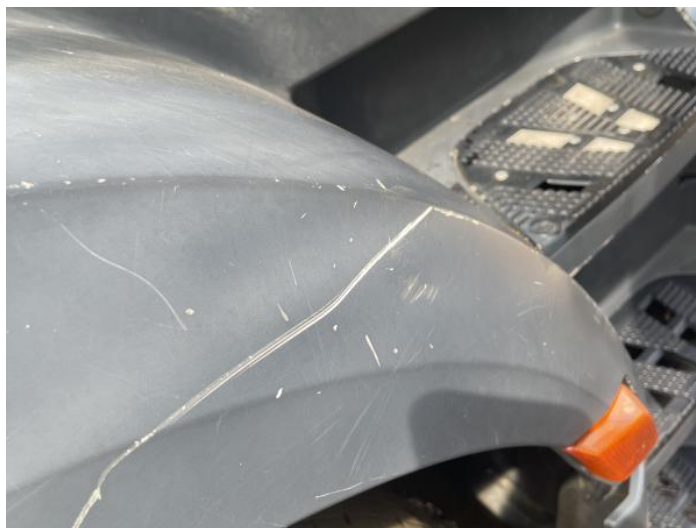
2: Door Moulding osf  
Scuffed (Unpainted)  
Over 100mm

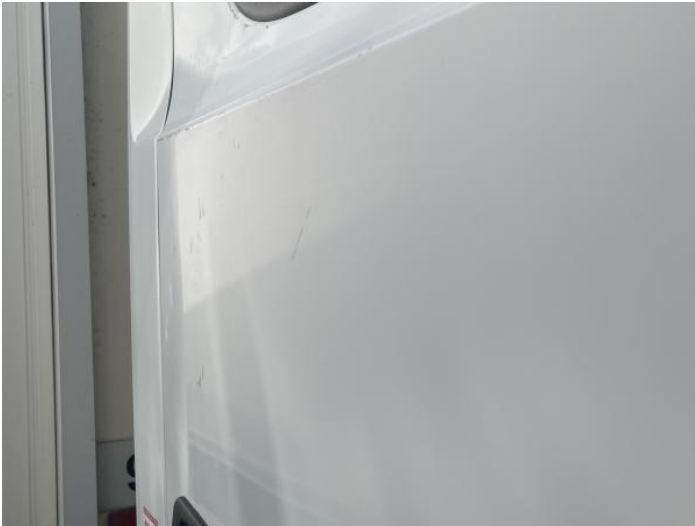
3: Door osf  
Dented  
With Paint Damage

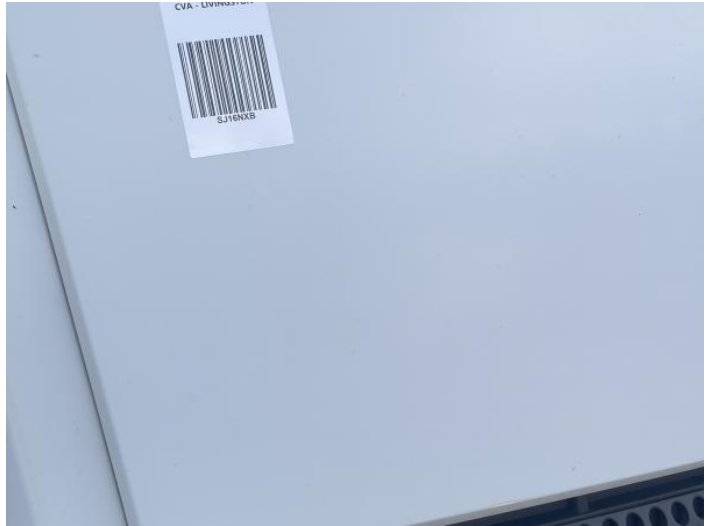
4: Bonnet  
Scratched  
UpTo 25mm Thru Paint

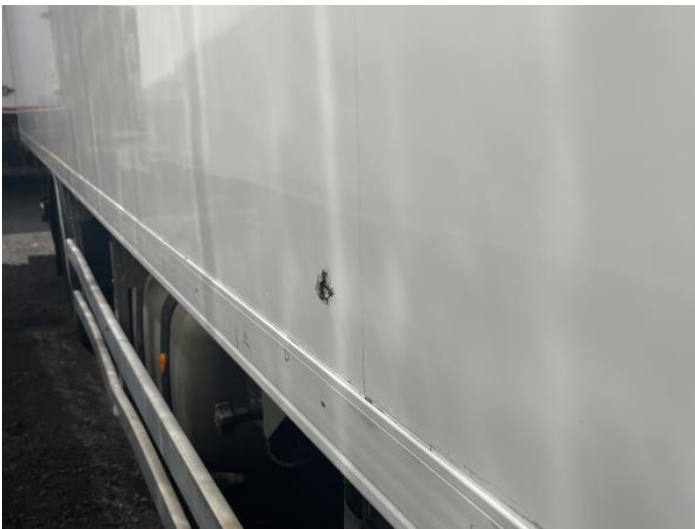
5: Qtr Panel osr  
Dented  
With Paint Damage

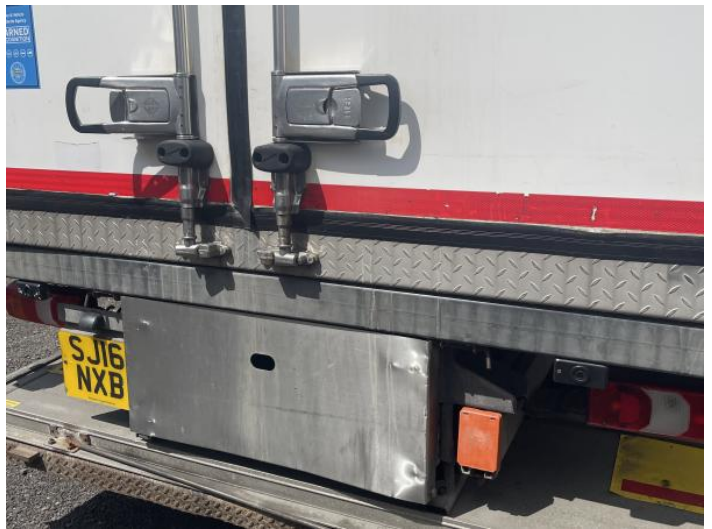
6: Tailgate  
Rusted  
Over 5mm

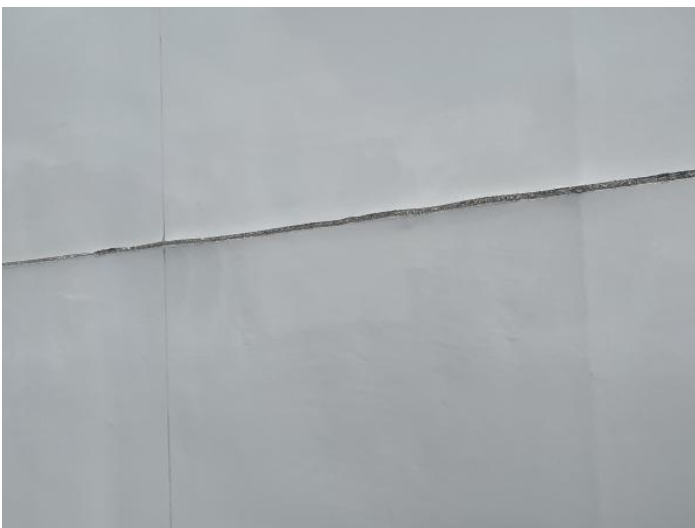
7: Qtr Panel nsr  
Dented  
With Paint Damage

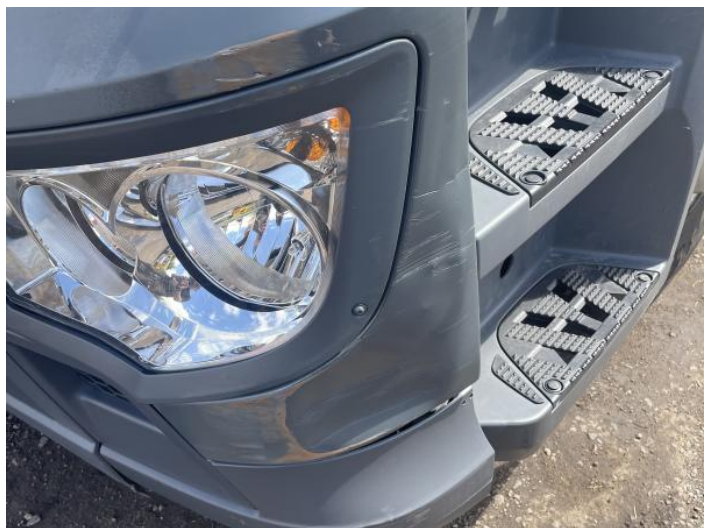
8: Bumper Front Moulding  
Scuffed (Unpainted)  
Over 100mm
